MARINE INVESTIGATION REPORT
M99C0005

GROUNDING AND HULL DAMAGE

THE BULK CARRIER "ALGONTARIO"
AT JOHNSON POINT, ST. MARYS RIVER, ONTARIO
5 APRIL 1999

Report Number M99C0005

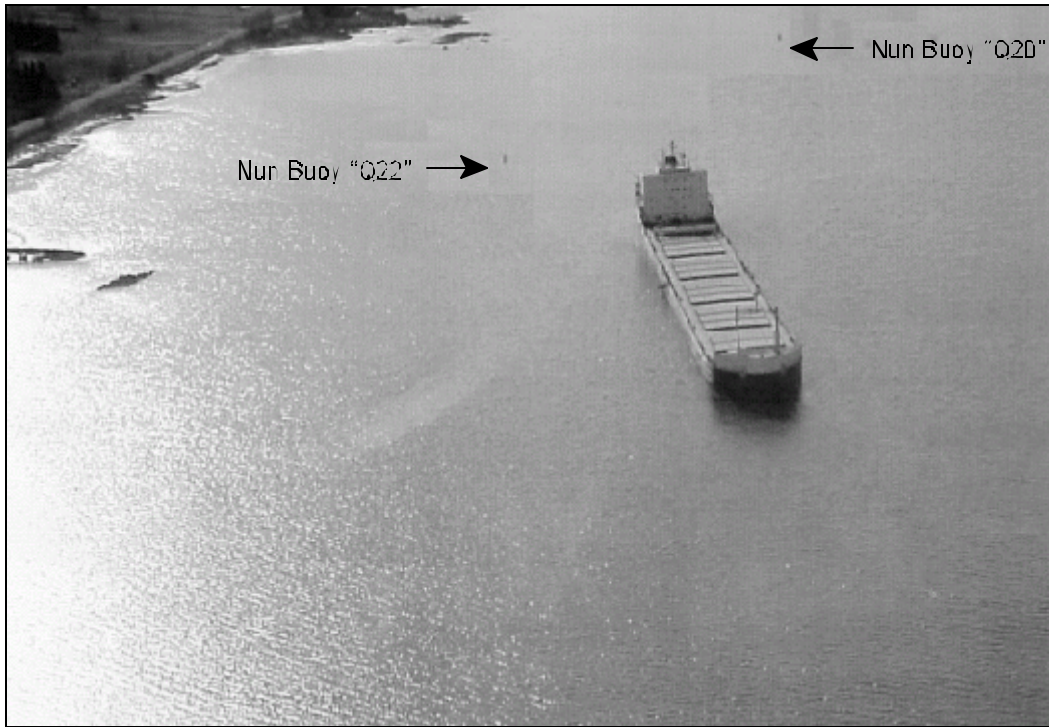
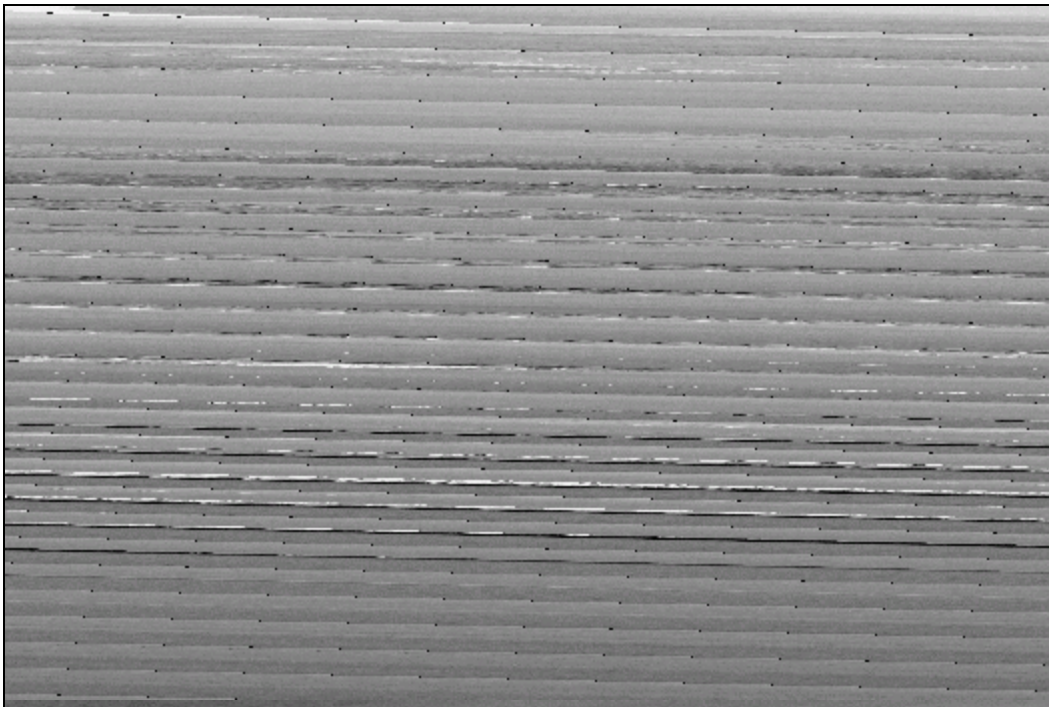
The overshoot of the intended turning point and the slower-than-anticipated rate of change of course caused the vessel to ground on the outer edge of the bend in the channel and incur extensive bottom shell damage on her starboard side.

Figure 6
"ALGONTARIO" hard aground; on 21-foot Project Depth Course 8
